3.8 GEOLOGIC HAZARDS

The project alignment is located in the Transverse Range geomorphic province of Southern California, which extends approximately 300 miles westward from the Mojave Desert to the Pacific Ocean. The Study Area lies within the northeastern portion of the Los Angeles Basin at the base of the San Gabriel Mountains. The Los Angeles Basin is a large trough, filled with marine and non-marine sediments. Deposition of marine sediments began approximately 65 million years ago in a deep, structural trough that existed off the coast of Southern California (Yerkes 1972). Over time, sedimentation slowly filled the trough with thousands of feet of sediments. About seven million years ago, as sedimentation continued, an eastward shift of the boundary between the Pacific and North American Plates began shaping the Los Angeles Basin from this deep trough. Deformation of the basin along contractional faults acted to shorten the basin in a north-south direction and uplift the bedrock units to form hills and mountains. Approximately two to five million years ago, the Elysian, Repetto, and Puente Hills were uplifted, predominately along northwest-trending faults (Shaw and Suppe 1996

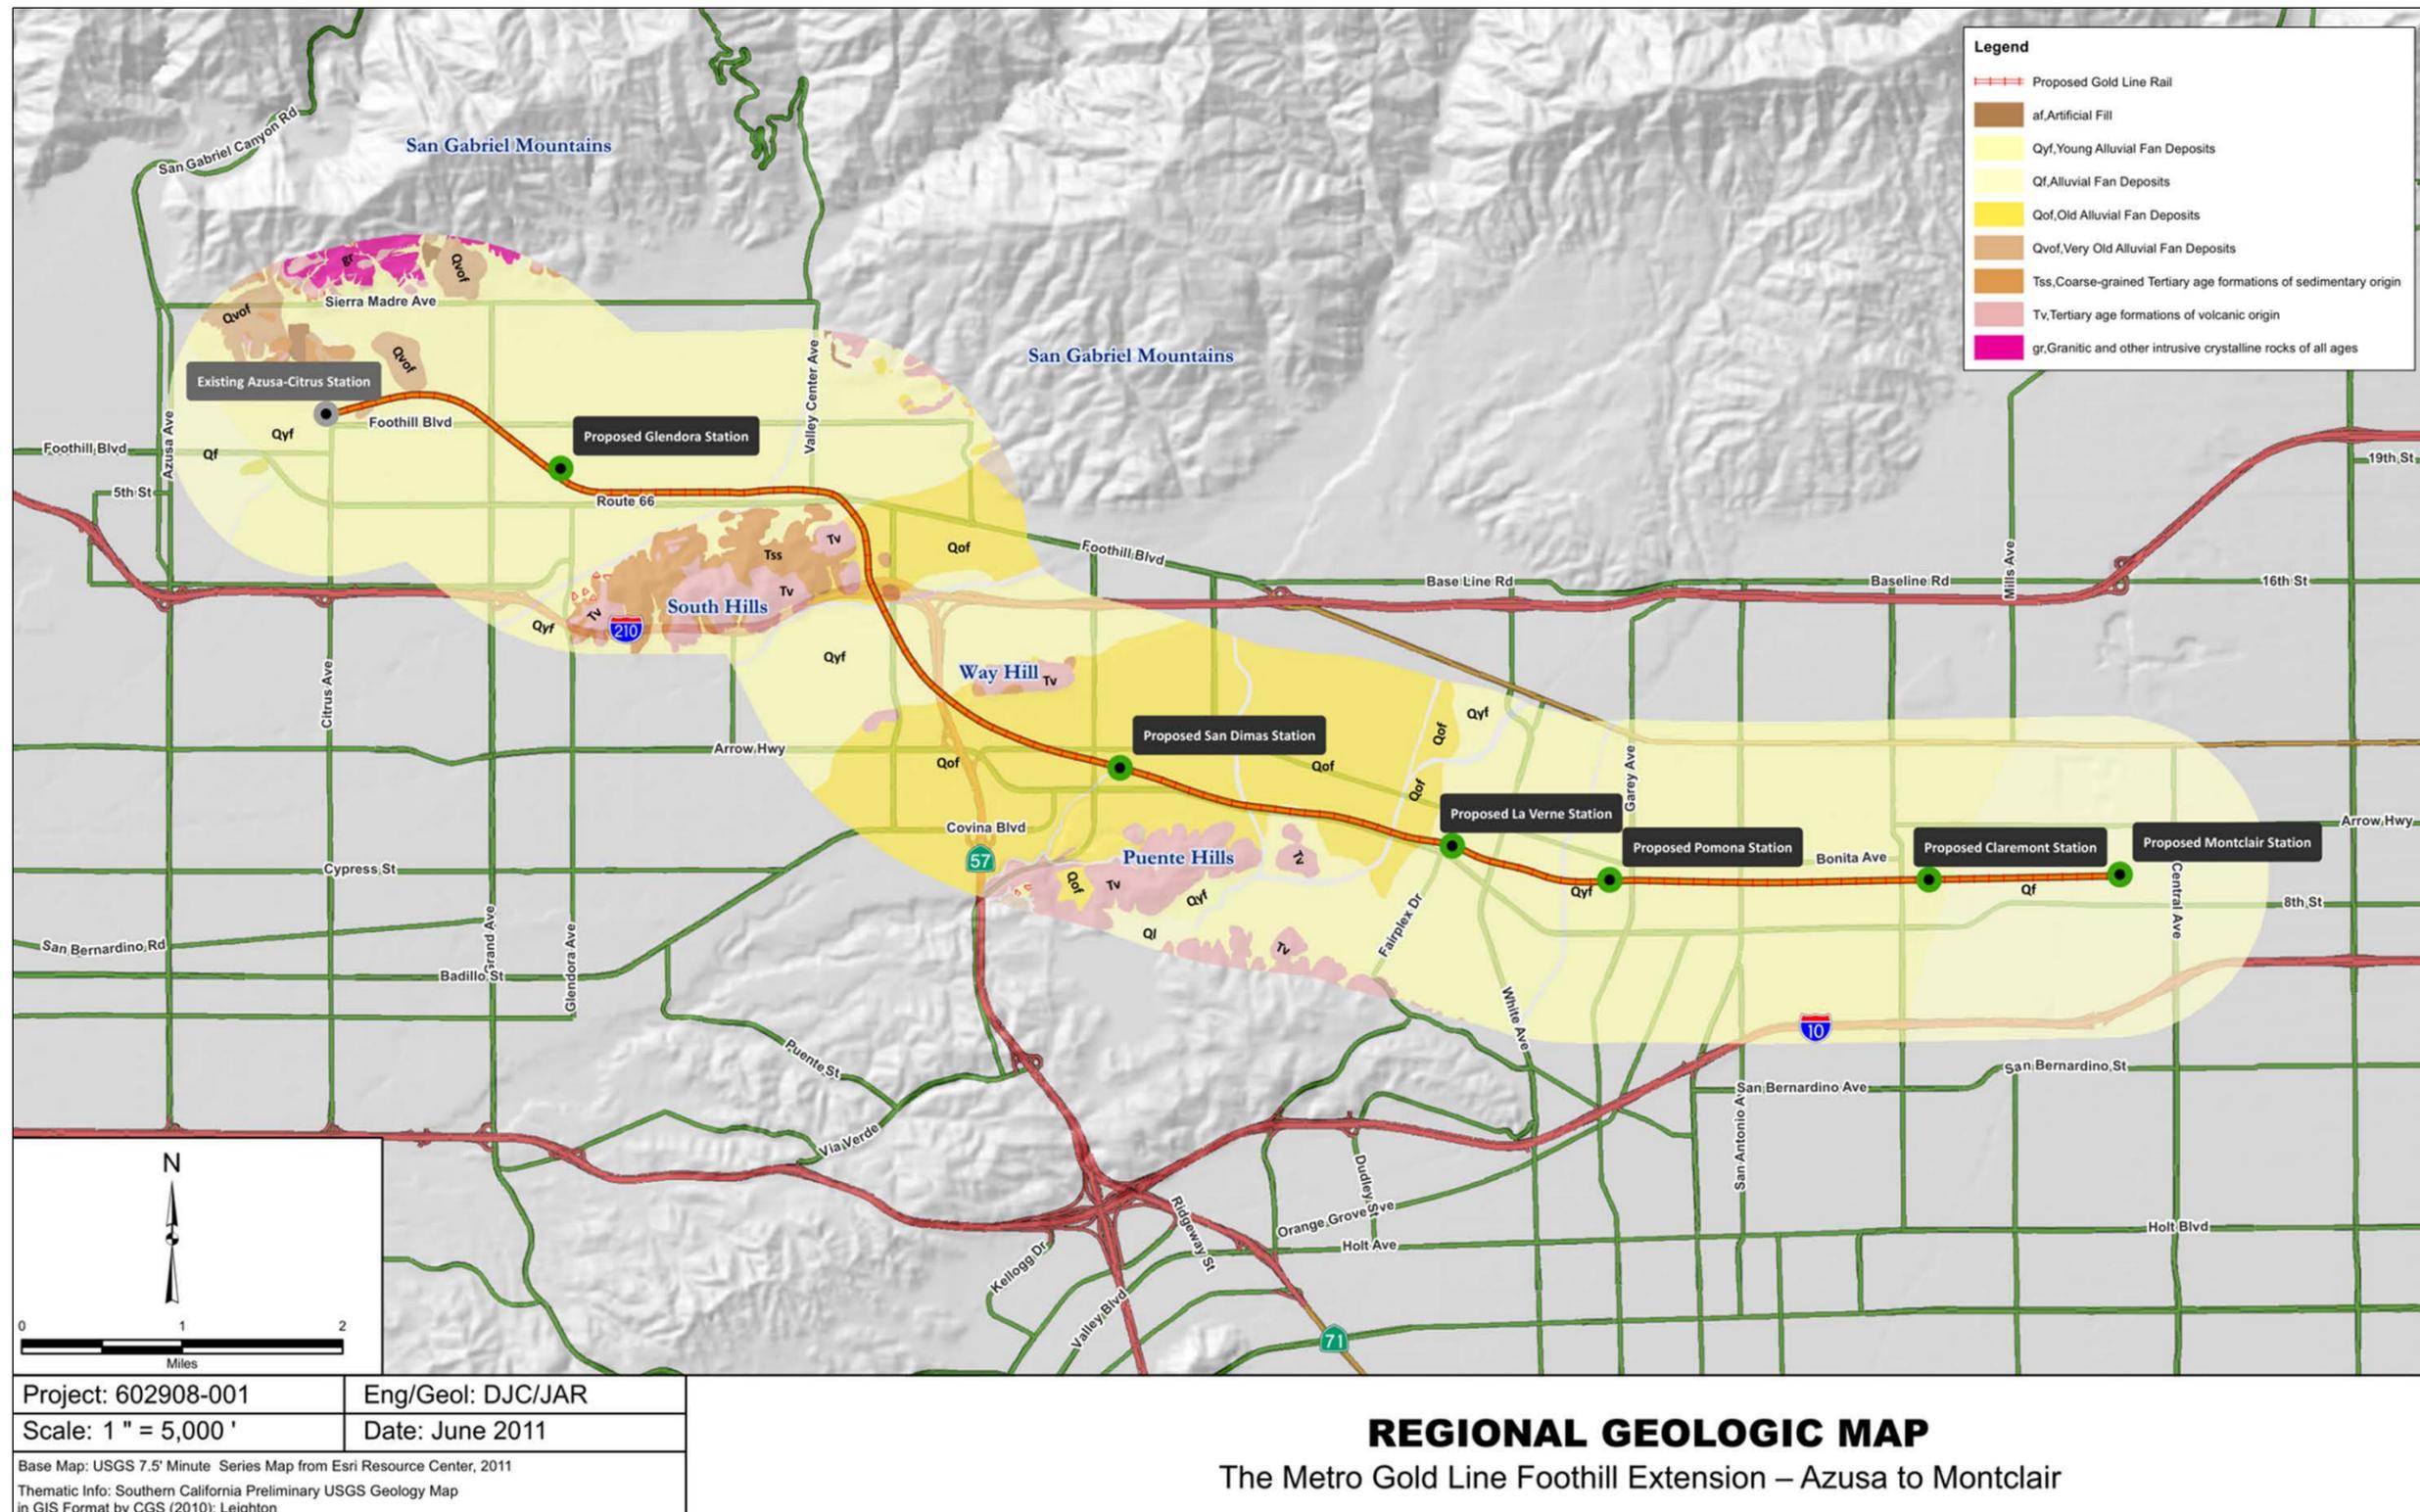
Figure 3.8-1. Regional Geologic Map (Los Angeles and San Bernardino Counties)

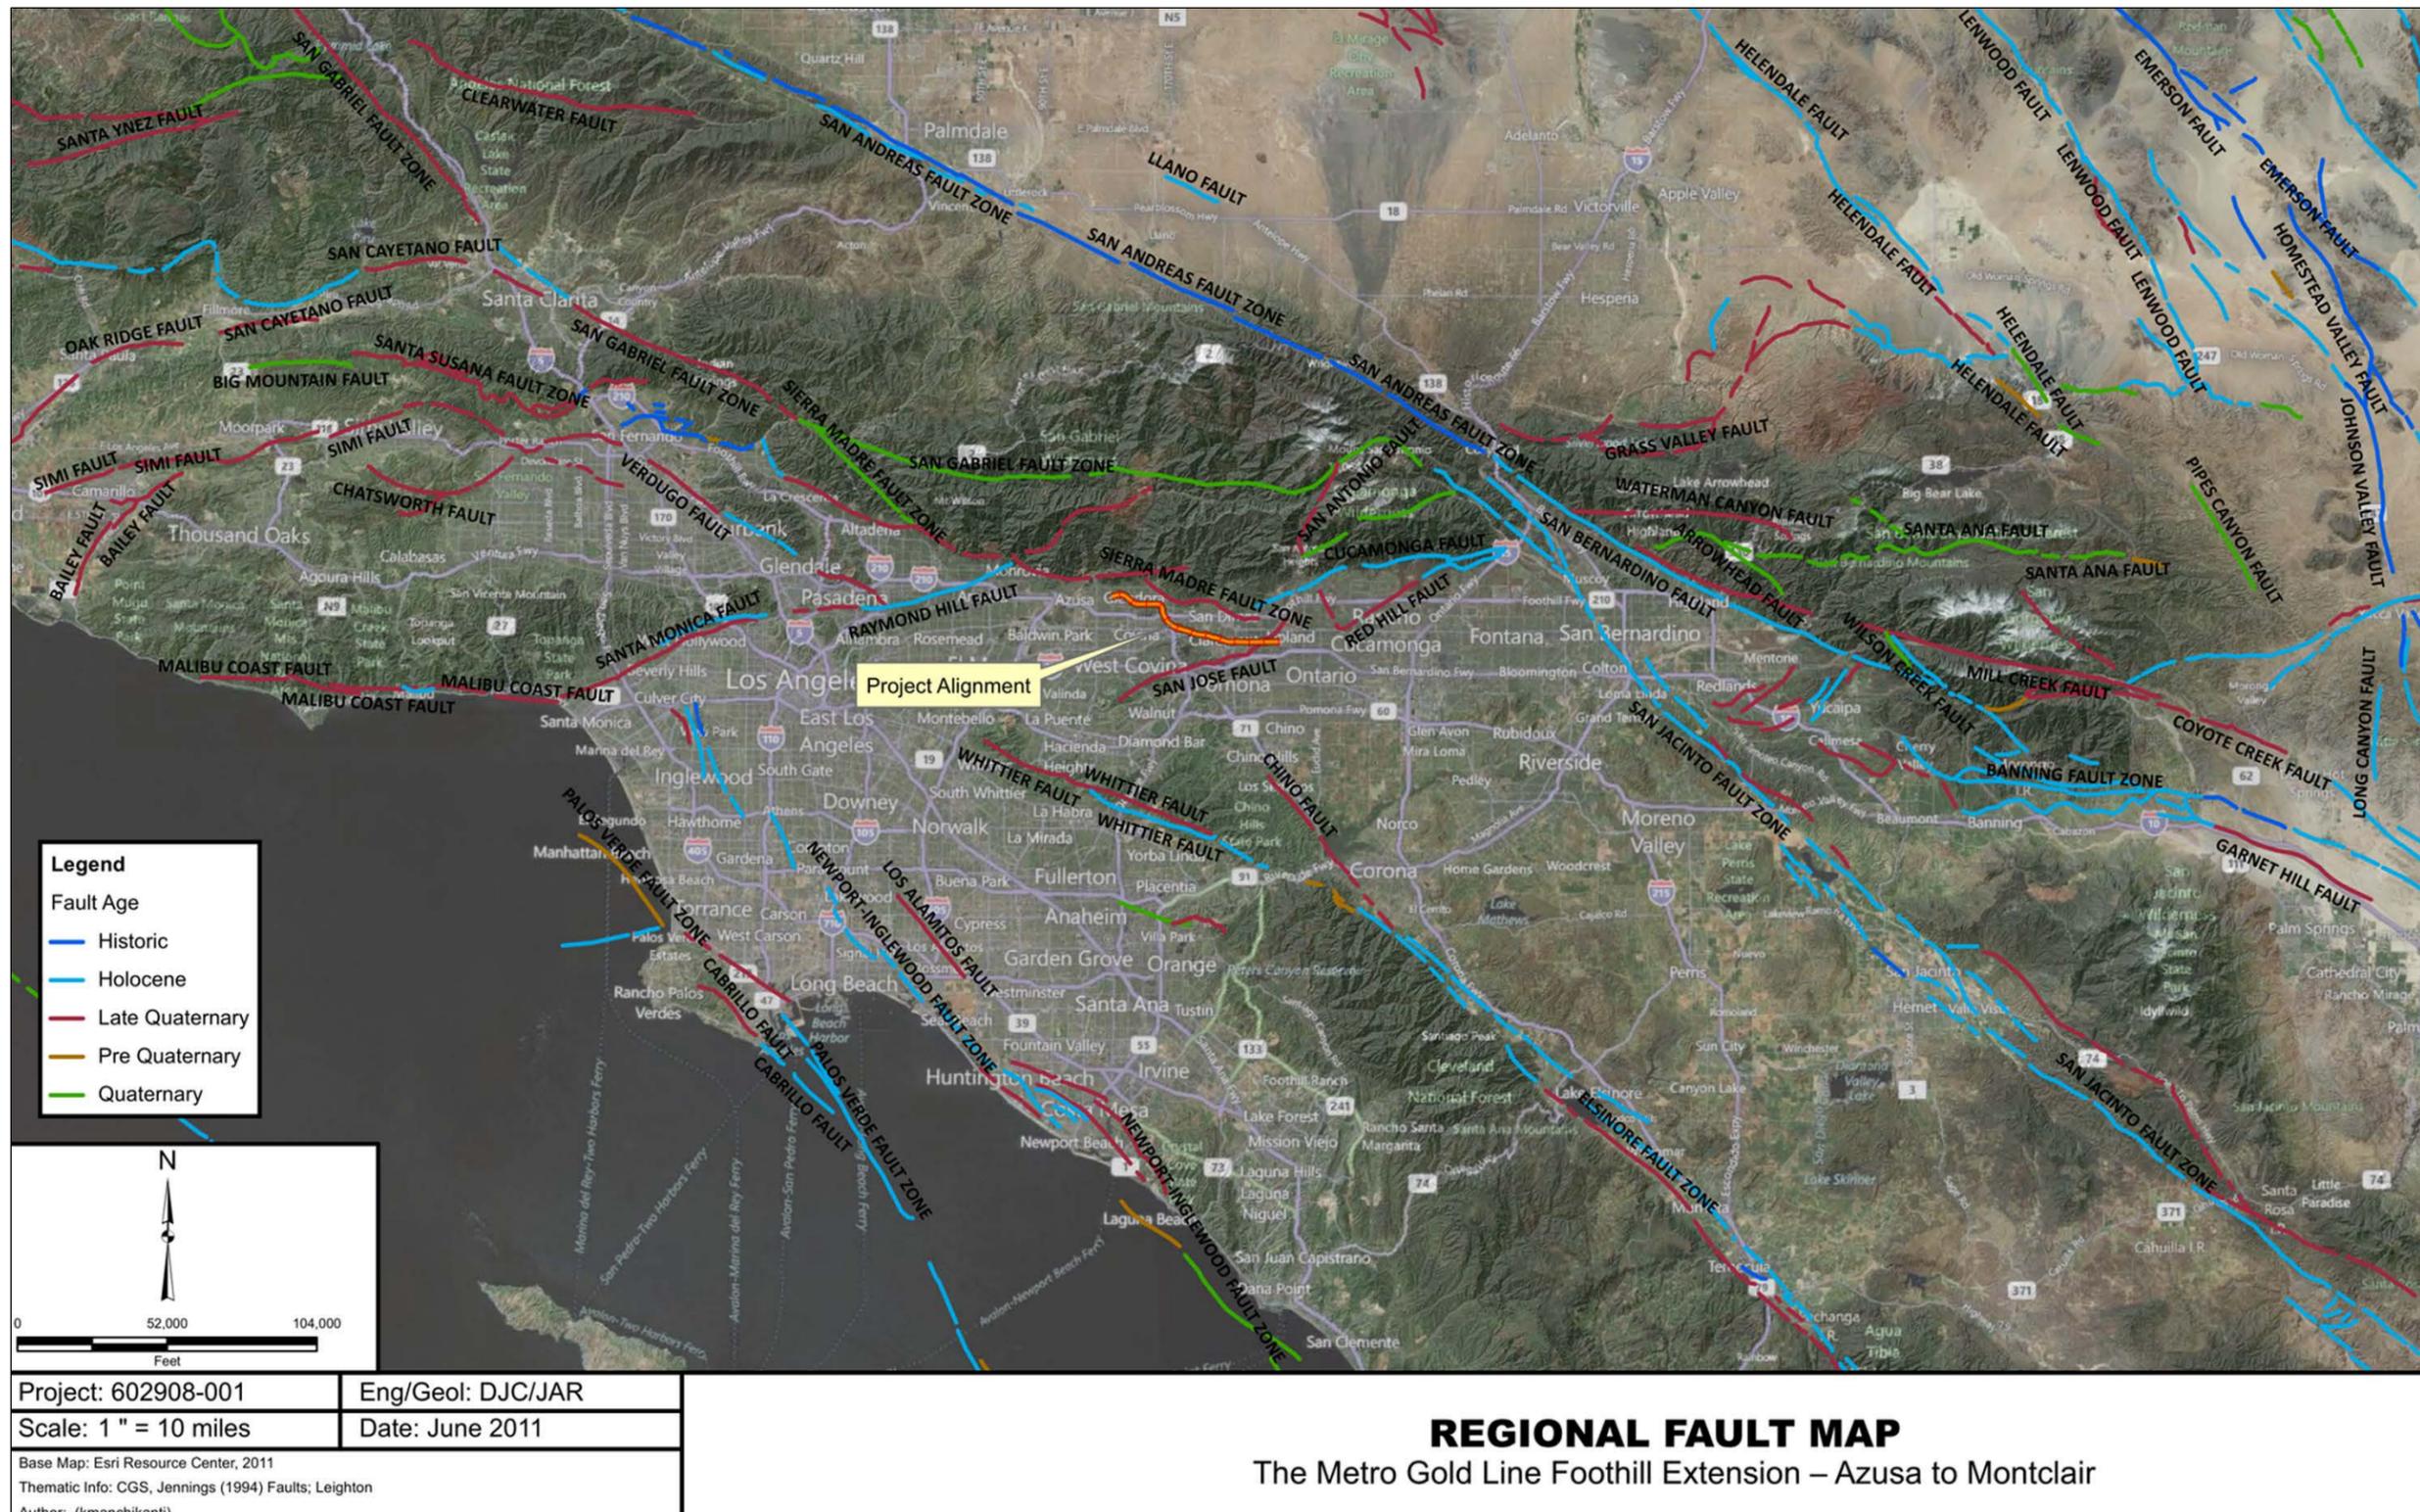
Figure 3.8-2. Regional Fault Map

Surface rupture can devastate structures built across an active fault. A fault is considered active if there is evidence of movement (either directly observable or inferred) along one or more of its segments in the last 11,000 years. Figure 3.8-2 shows the project alignment and the active and potentially active faults in the region. To protect structures from the hazard of ground-surface rupture along a fault line, the California Geological Survey (CGS), under the State-mandated *Alquist-Priolo Earthquake Fault Zoning Act*, has delineated “earthquake fault zones” along well-defined active or potentially active faults. No earthquake fault zone crosses the project alignment; however, the Duarte and San Jose Faults and other local faults are known to cross the project alignment, and many active and potentially active faults are located in the region (Figure 3.8-2). Ground rupture from these faults and strong ground shaking from an earthquake on one of these regional faults could adversely affect the Study Area.

Numerous active and potentially active faults lie within a few miles of the Study Area. Descriptions of the more prominent faults near the site and a few that cross the alignment are provided below. The descriptions indicate the type of fault, approximate distance to the proposed alignment, maximum potential earthquake in terms of magnitude (M). M is a measurement of an earthquake’s magnitude based on area of the fault, amount of movement during the earthquake, and the strength of the rocks ruptured during the earthquake.

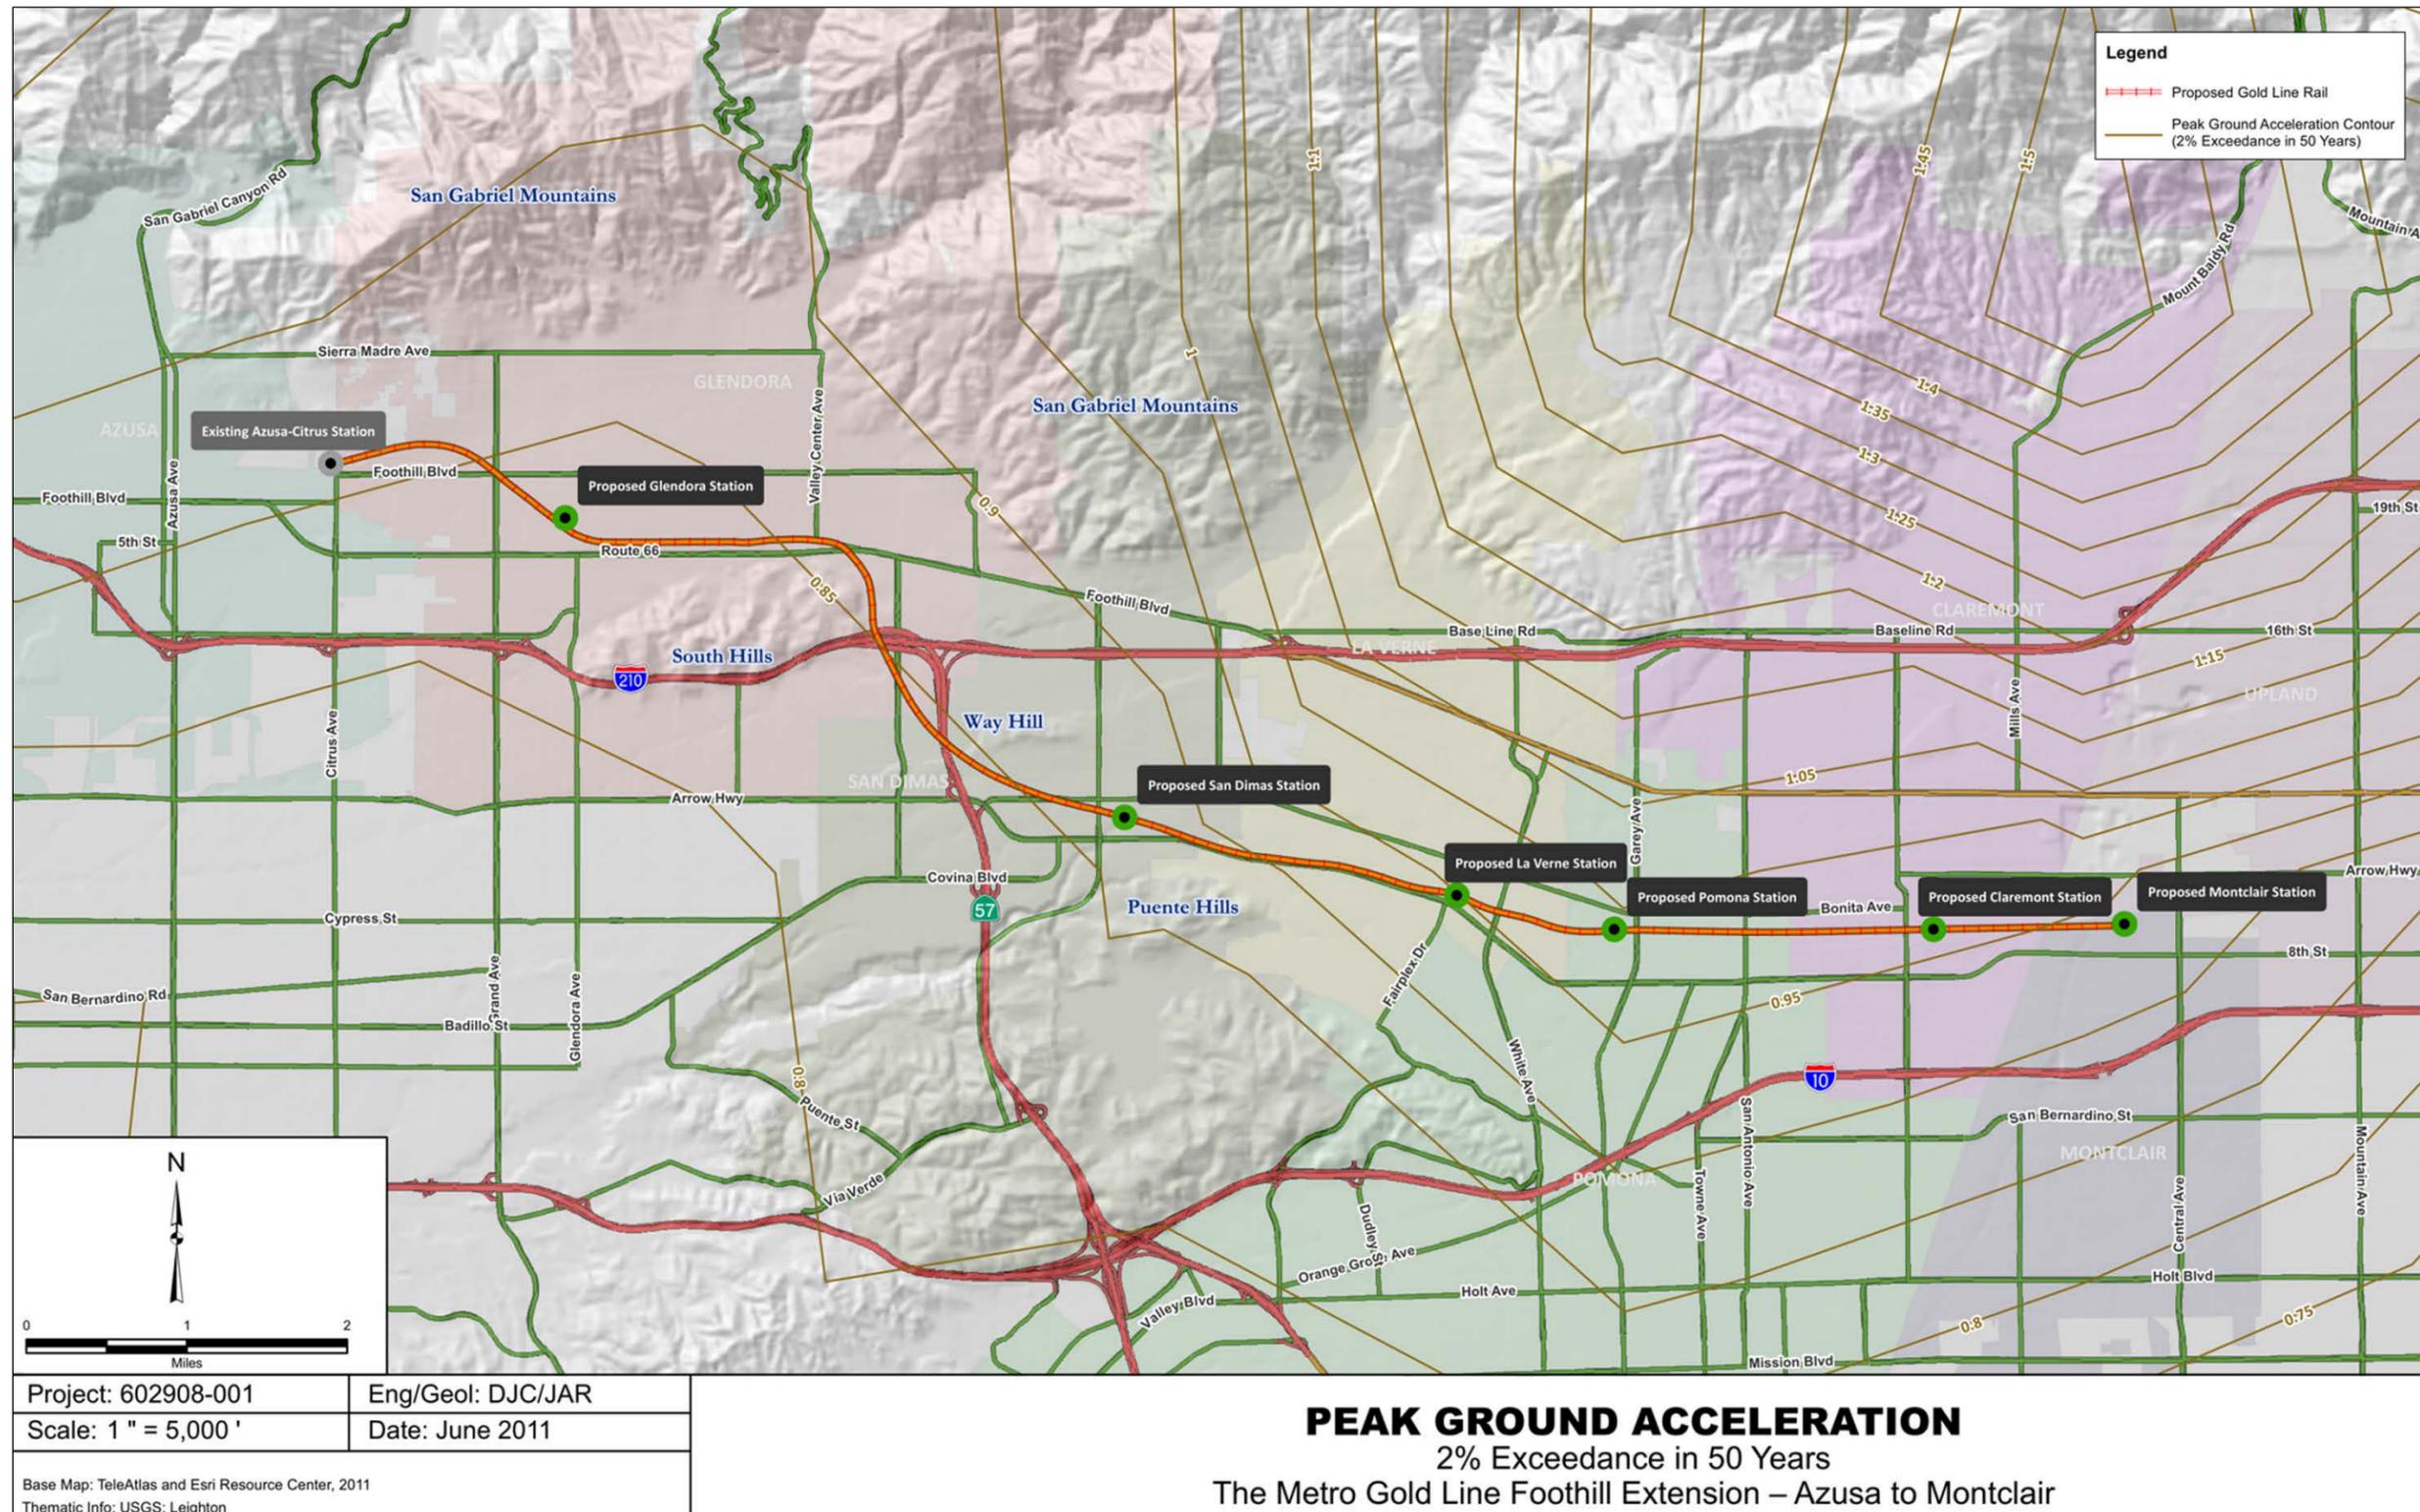
Figure 3.8-3. Peak Ground Acceleration

Peak Horizontal Ground Acceleration (PGA) is generally used to evaluate the intensity of ground motion. For a general evaluation of the project alignment, a deterministic seismic hazard analysis was performed. The analysis estimated the expected PGA values along the alignment based on a maximum earthquake magnitude along any of the faults in the region. In addition to the earthquake magnitude, PGA values are affected by the type of material that underlies the site. For this evaluation, it was assumed, based on the information presented in Figure 3.8-1, that alluvium underlies the Study Area and, therefore, the attenuation relationship for alluvium was used to calculate the PGA expected along the alignment (United States Geological Survey Open-File Report 2010-1296).

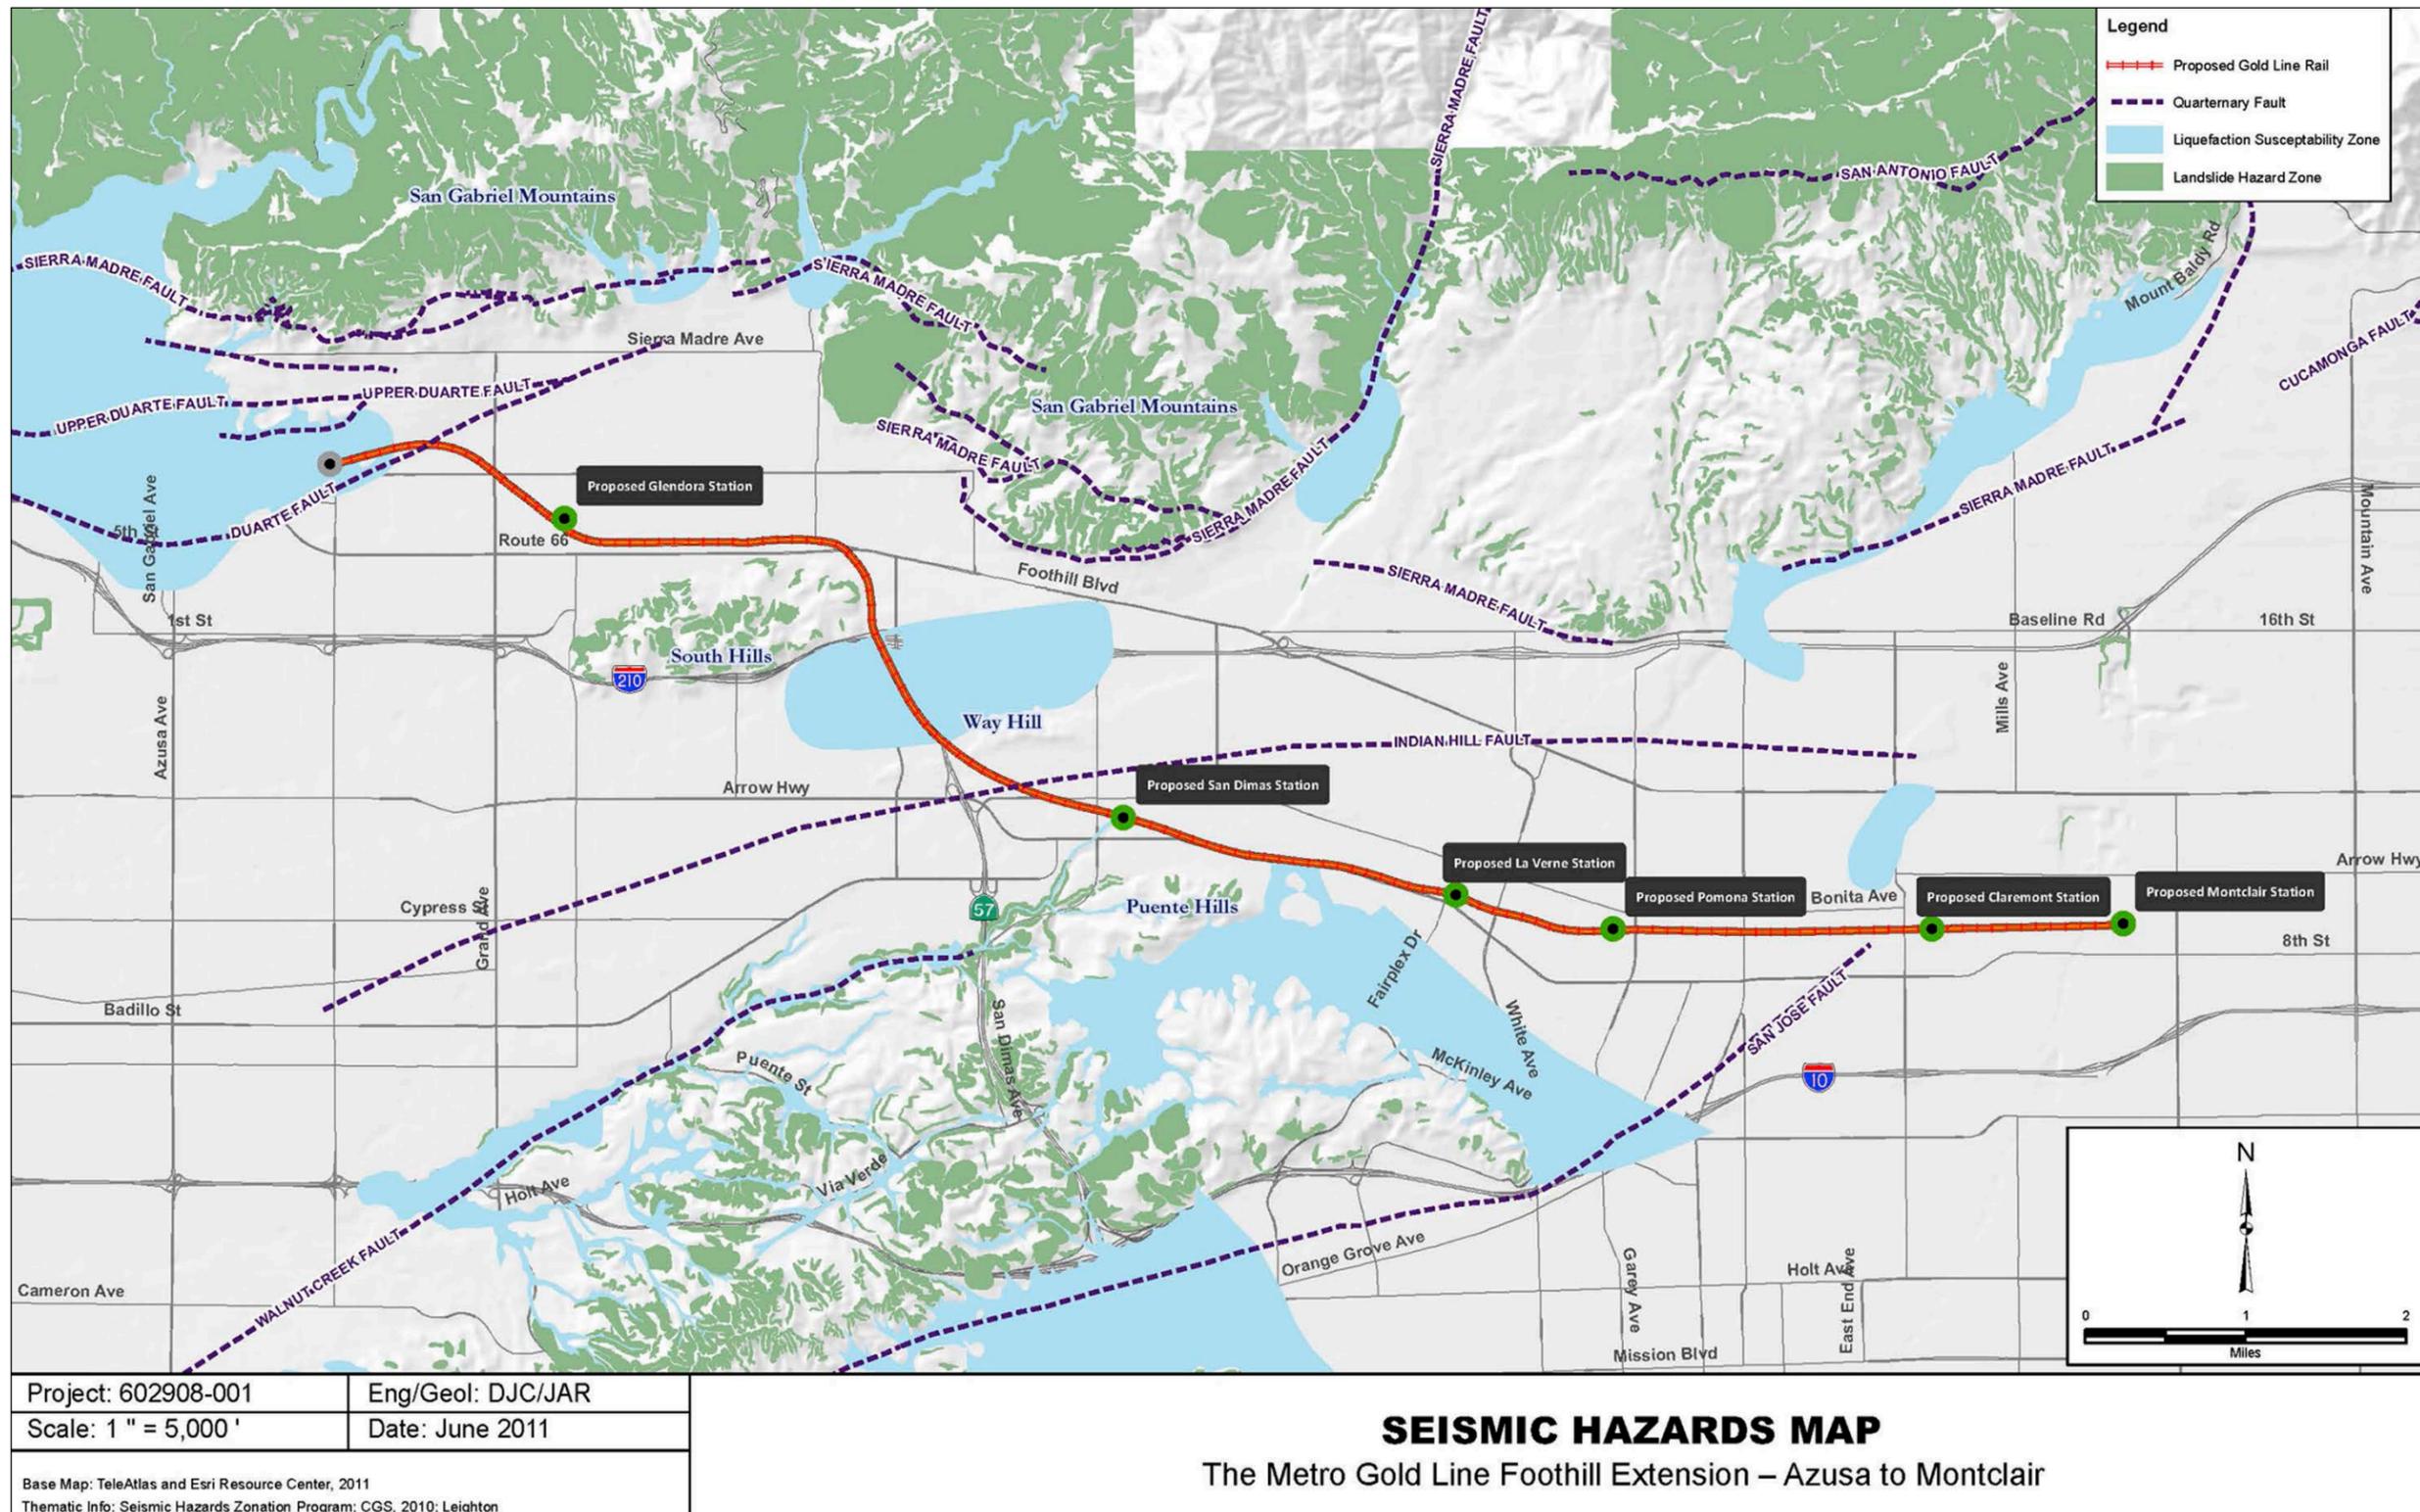
Figure 3.8-4. Seismic Hazards Map—Los Angeles and San Bernardino Counties

Most of the project alignment is located on flat terrain. The few slopes that exist are those constructed for railroad bridges to cross above local roads and streams. These manmade slopes appear in good, stable condition. However, within the alignment buffer zone there are a few areas where slope instability could exist, particularly during an earthquake. These areas are mapped as potential seismically induced landslide zones on the Seismic Hazard Zones Maps and Reports (Figure 3.8-4) (California Division of Mine and Geology 1999a, 1999b, 1999c, and 1999d; Perez et al. 1998; Schlosser and Wills 1998a and 1998b). A seismically induced landslide zone is an area where previous landslides have occurred or an area where conditions exist for potential permanent ground displacement such that mitigation (as defined in Public Resources Code Section 2693(c)) would be required. These areas include the northern slopes of the South Hills and Puente Hills. In these areas, seismically induced landslides could occur if shaking from an earthquake were to cause preexisting landslides to reactivate or trigger new landslides along planes of weakness. For the rest of the alignment, which is not within the seismically induced landslide zones, the potential for this hazard is low.
