#### FIELD INSPECTION

The building at 736 North Angeleno Avenue is a relatively small (approx. 714 square feet), one-story single-family residence of wood-frame construction. Simple and utilitarian in appearance, it does not demonstrate the character-defining features of any established architectural styles, but exhibits characteristics in materials and design that are consistent to similar residential buildings dating to the early 20th century (Fig. 3).

MTA Gold Line Foothill Extension, Phase 2A

Geology and Hazardous Materials Evaluations Michillinda TPSS Alternatives A, B and C

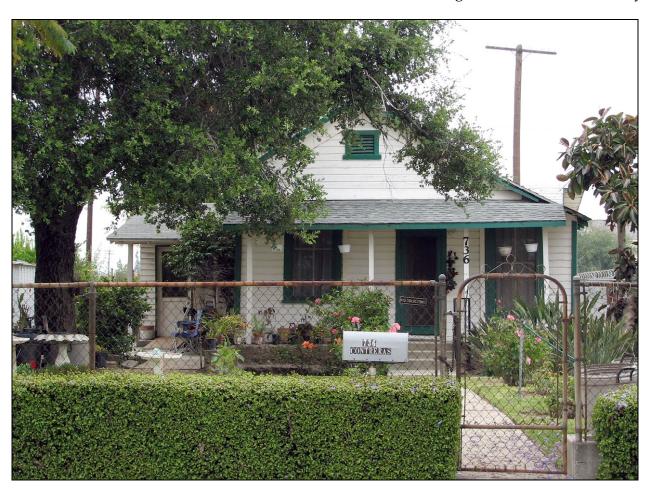
The residence is built on a generally L-shaped plan, resting on a raised concrete foundation. The medium-pitched front-gable roof over the main mass is covered with dark, greenish gray composition shingles, as are the shed roof of the front porch and the shed and gable roofs over the northern wing. A large lean-to at the rear, probably a later addition, is surmounted by a low-pitched shed roof sheathed with composition sheets of a lighter gray color (Fig. 4). Most of the eaves are narrow and open, with the rafter tails exposed underneath. The rear lean-to, in contrast, sports much wider rake overhangs and an eave that extends into a covered patio, with its roof supported by square wooden posts.

Figure 3. Residence at 736 North Angeleno Avenue, view to the east. (Photo taken on June 9, 2011).
